STRESS CORROSION CRACKING OF TYPE 304 STAINLESS STEEL

STATUS REPORT - MARCH 1, 1964

M. R. LOUTHAN, JR.

Savannah River Laboratory

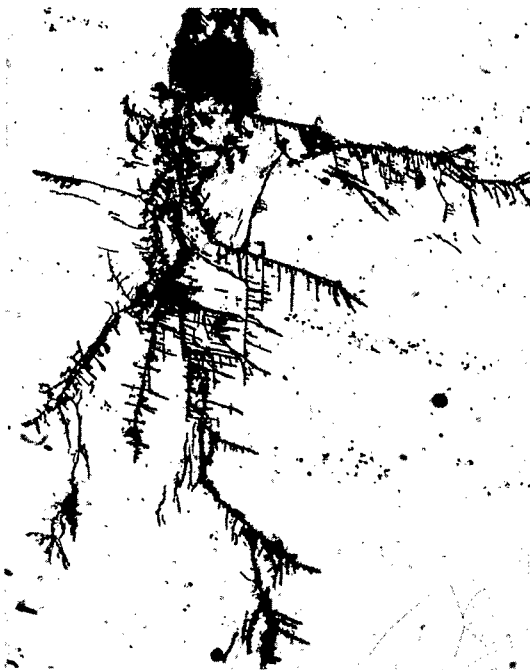
NEG. EM20

- a. Note the Widmanstätten pattern of the crack. (Specimen polished parallel to sample surface.)

FIG. 4 TYPICAL STRESS CORROSION CRACKS IN GROUND SAMPLES

The cracks in the dry-ground samples were principally transgranular and formed pronounced Widmanstätten patterns in several cases (Figure 4). Grain boundary and twin boundary cracking were also observed in limited regions (Figure 3).

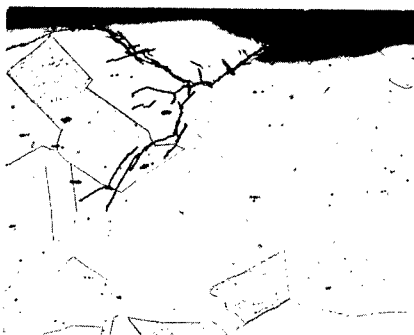
NEG. EM16

- c. Note that the cracks often change directions at grain and twin boundaries. (Specimen polished perpendicular to the sample surface.)

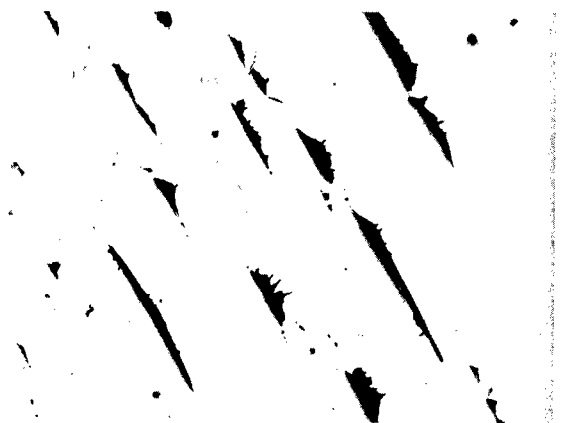
NEG. 1448D

c. Cracking occurring within grains.

FIG. 7 SECOND-PHASE PRECIPITATION AND CRACKING IN THE SURFACES OF
CATHODICALLY CHARGED TYPE 304 STAINLESS STEEL SPECIMENS

[The as-charged samples exhibited no evidence of a second-phase precipitate or cracking; however, after aging approximately 3-1/2 hours at room temperature, incipient precipitation was observed] (Figure 7a), [and after 5-1/2 hours second-phase platelets (or needles) were seen] (Figure 7b). This precipitate was not identified; however, it was probably the same phase that Vaughan, et al.,⁽¹¹⁾ described as iron hydride. Cracking often occurred in the specimen surface during second-phase precipitation and such surface cracks were observed adjacent to the second phase both within the grains (Figure 7c), and along grain boundaries (Figure 7d). These observations agreed with the previous work, which showed that the formation of transgranular cracks accompanied precipitation of a second phase.

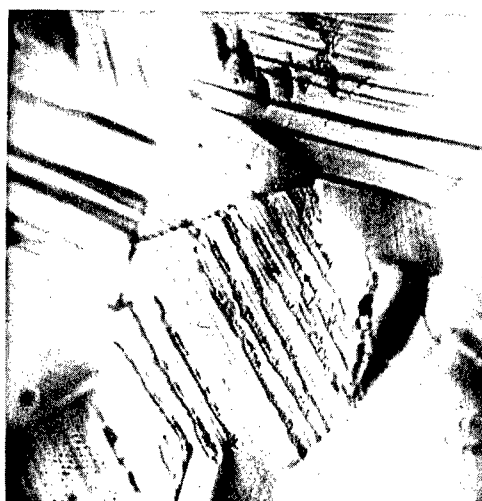
NEG. EM270

b. Extension of pits to form linear traces of corrosion parallel to slip lines. Exposure 15 minutes.

FIG. 8 SEQUENCE OF CRACK INITIATION IN TYPE 304 STAINLESS STEEL U-BEND SPECIMEN IN BOILING $MgCl_2$

- Initially, corrosion pitting occurred in localized areas (Figure 8a).
- The pitting was followed by extension of the corrosion to form linear traces of corrosion product on the sample surfaces; these traces were often parallel to observable slip traces (Figure 8b).
- Additional exposure caused cracking to occur in the corroded regions (Figure 8c).
- At still greater exposures, the small cracks within each grain connected to form the branching, trans-granular cracks shown in Figure 8d. By this time the crystallographic nature of the cracks was not readily apparent. However, the branches often changed directions at grain boundaries, and many of the branches were parallel to slip lines.

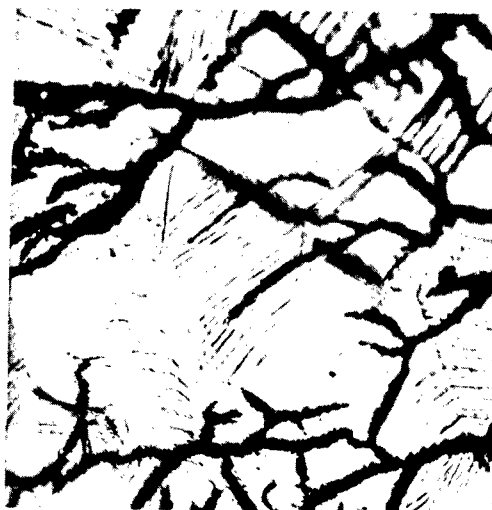
NEG. EM275

d. Pattern of well-developed cracks. Exposure 30 minutes.

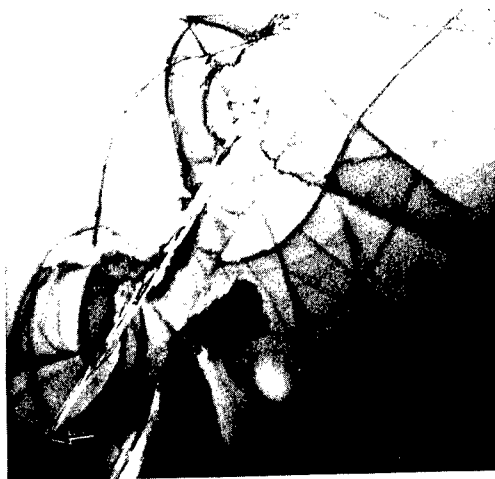
NEG. 1714D

FIG. 11 TIP OF CRACK PRODUCED IN TYPE 304 STAINLESS STEEL FOIL DURING 15-MINUTE EXPOSURE TO DILUTE NaCl SOLUTION AT 100°C. Corrosion product was identified by selected-area electron diffraction in the vicinity of the crack tip and a stacking fault is apparent at A.

- ✕ The frequency of cracking increased with increasing exposure to the chloride solutions.
- ✕ Electrochemical attack accompanied crack growth. This can best be seen in Figure 11 where corrosion products were identified in the vicinity of the crack tip.
- ✕ Cracks already in existence propagated during subsequent exposures (Figure 12).
- ✕ Cracks propagated preferentially along planar arrays of dislocations and along stacking faults.
